Manhole Inspection Summary

Manhole # S35II1009MH

Insp Date: **1/22/07 3:01 PM**

Location Address: **WENDOVER RD** Cross Street: **UNDERWOOD RD**

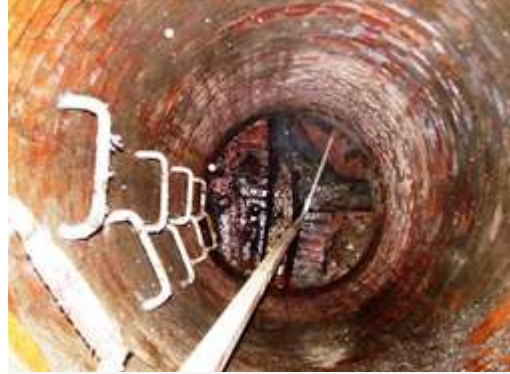
Top View

Corroded steps. Bench and Channel debris.

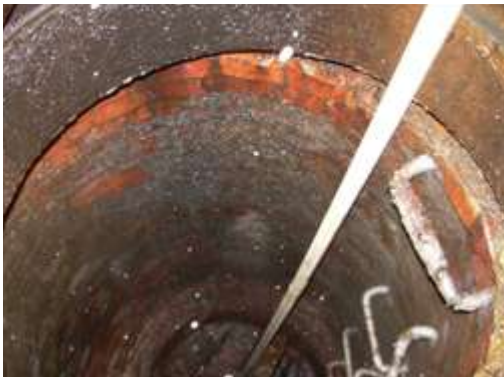
Defect

Frame leaks. Frame offset. Adjustment deterioration and infiltration. Corbel and Barrel infiltration.

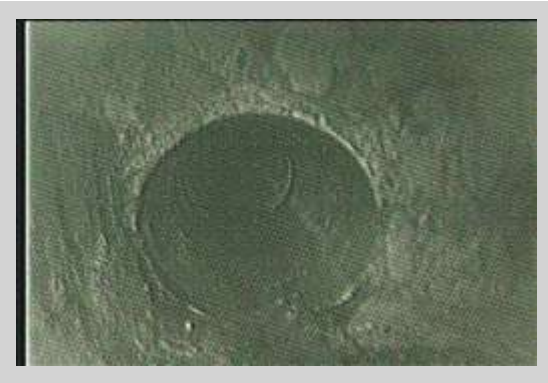
8 in. Circular Gravity Sewer Pipe Out @ 12 O'Clock

Deposits: ☐ None ☐ **Mud** ☐ Sludge ☒ **Debris** ☒ **Grease**

Silt Depth: **0** (in.) Deposits Extent: **Light**

Infiltration: **None** Pipe Seal Cond: **Cracked**

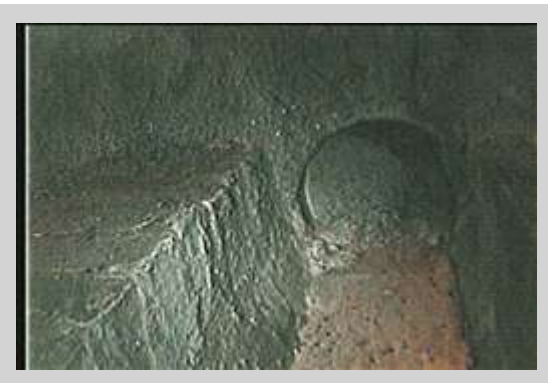
8 in. Circular Gravity Sewer Pipe In @ 3 O'Clock

Deposits: ☐ None ☒ **Mud** ☐ Sludge ☒ **Debris** ☐ Grease

Silt Depth: **3** (in.) Deposits Extent: **Medium**

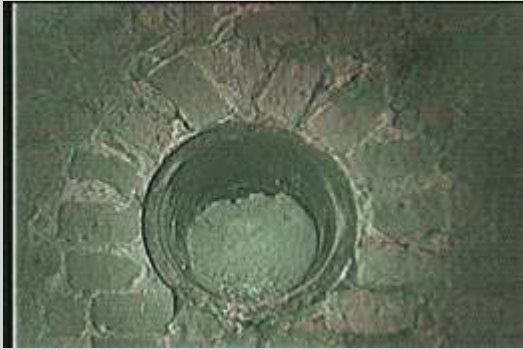
Pipe In @ 6 O'Clock

Deposits: ☐ None ☒ **Mud** ☐ Sludge ☒ **Debris** ☐ Grease

Silt Depth: **0** (in.) Deposits Extent: **Heavy**

Infiltration: **Evidence**

Pipe Seal Cond: **Roots**

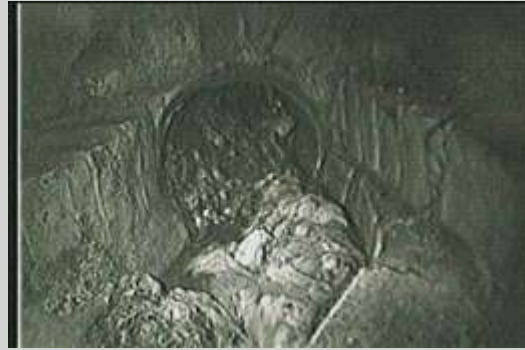
Drop In @ 6 O'Clock

Drop: **Outside** Rod and Bar

Drop Condition: **Open**
